# **Local and Regional Environmental Impacts from the U.S. Metals Refining Company Facility Operations in Carteret, New Jersey**

**Reichhold, Inc.**

August 2008

**CH2MHILL**

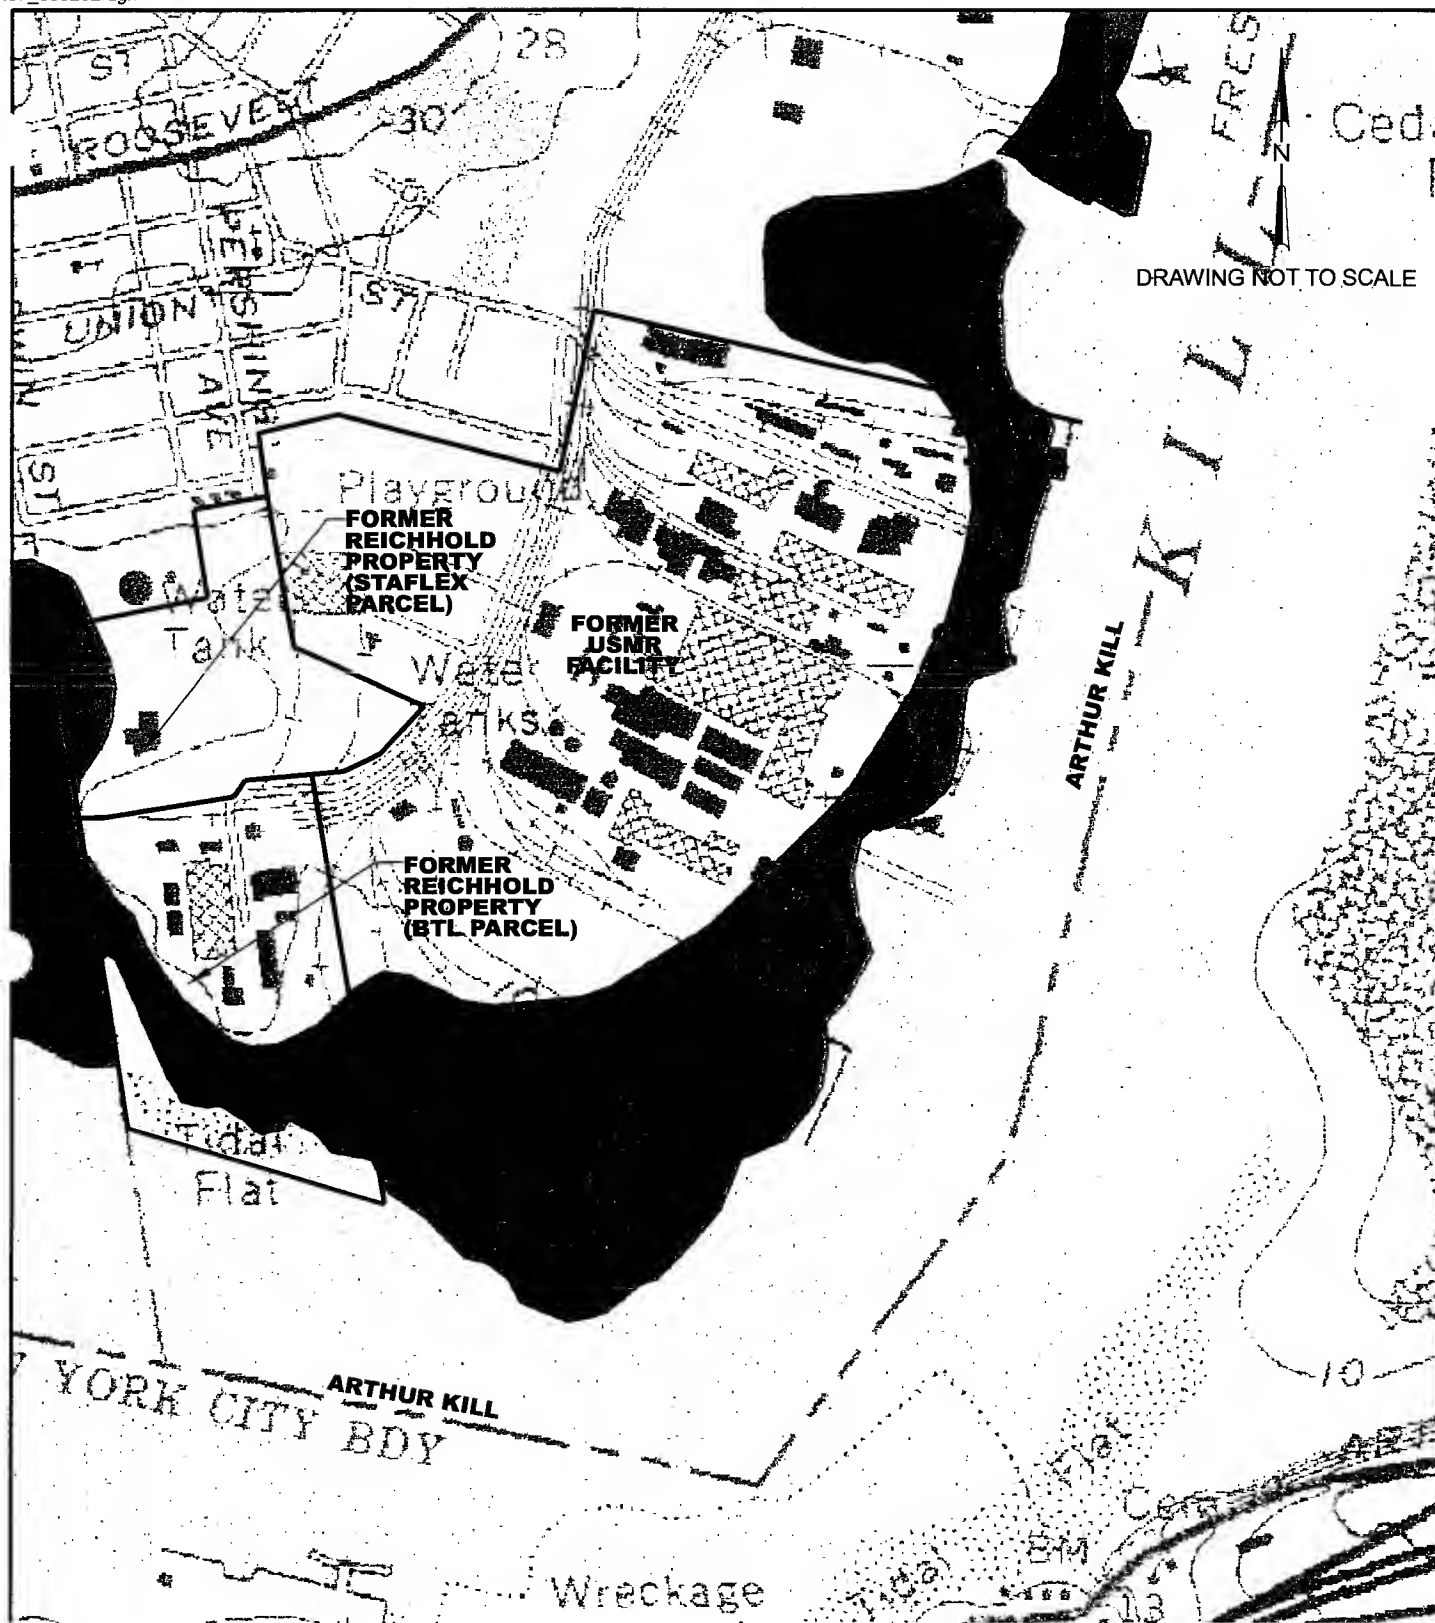
Figure 1-4  
1948 Aerial Photograph  
East Perspective

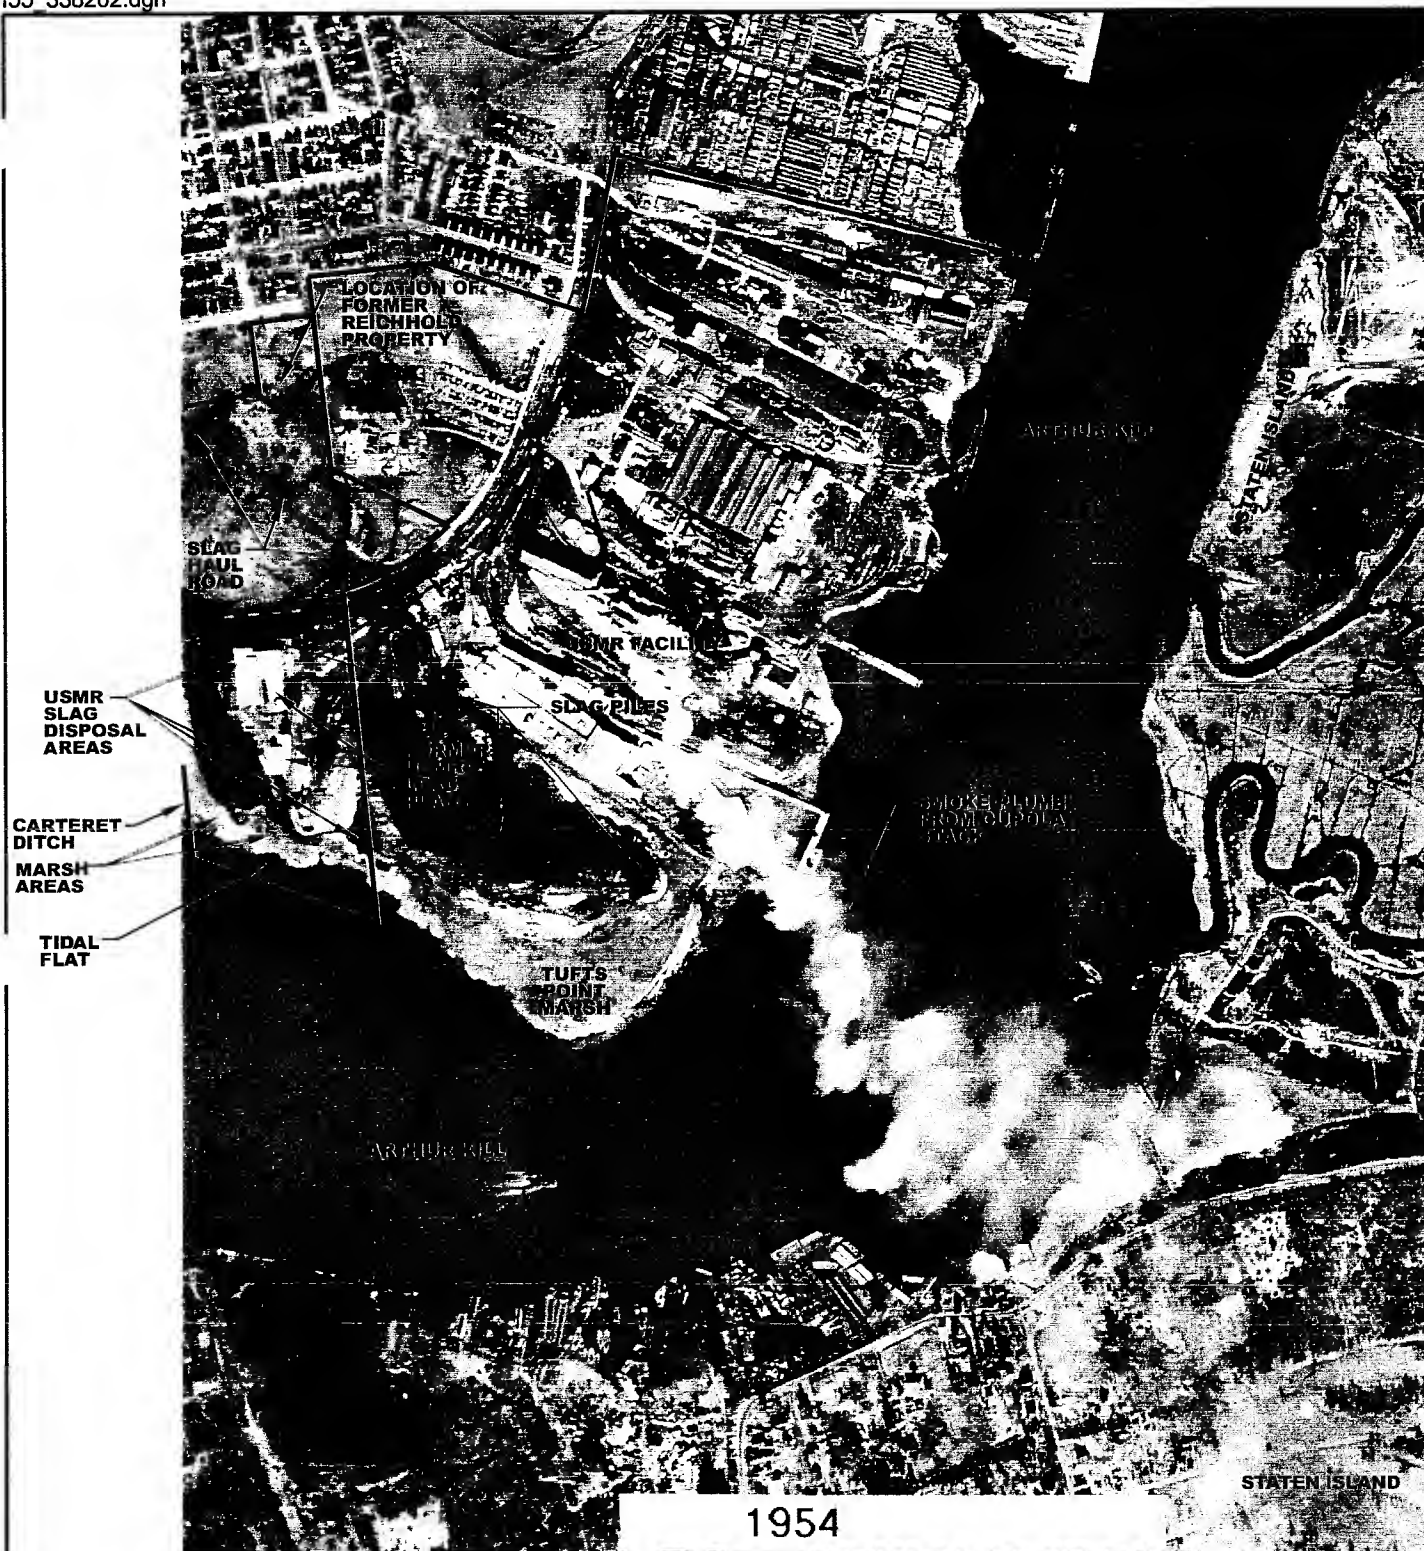
Figure 2-1  
**Historic Fill Areas Within and  
 Surrounding USMR Property  
 as of January 2008**

The NJDEP, in accordance with the Brownfield and Contaminated Site Remediation Act (N.J.S.A. 58:10B-1 et seq.) has prepared maps of the entire state of New Jersey that show the locations of historic fill. Historic fill is defined by the NJDEP as "non-indigenous material placed on a site in order to raise the topographic elevation of the site." The NJDEP notes that "some areas mapped as fill may contain chemical-production waste or ore-processing waste that exclude them from the legislative definition of historic fill." Figure 2-1 depicts the extent of historic fill as mapped by the NJDEP, for the USMR site and surrounding area. As depicted on Figure 2-1, the entire eastern and southern portions of the USMR site, on the banks of the Arthur Kill, and portions of the former Reichhold site have been filled in. The extent of historic fill in the southern portion of the USMR site (Tufts Point) is especially widespread, extending approximately 1,000 feet inland from the shoreline.

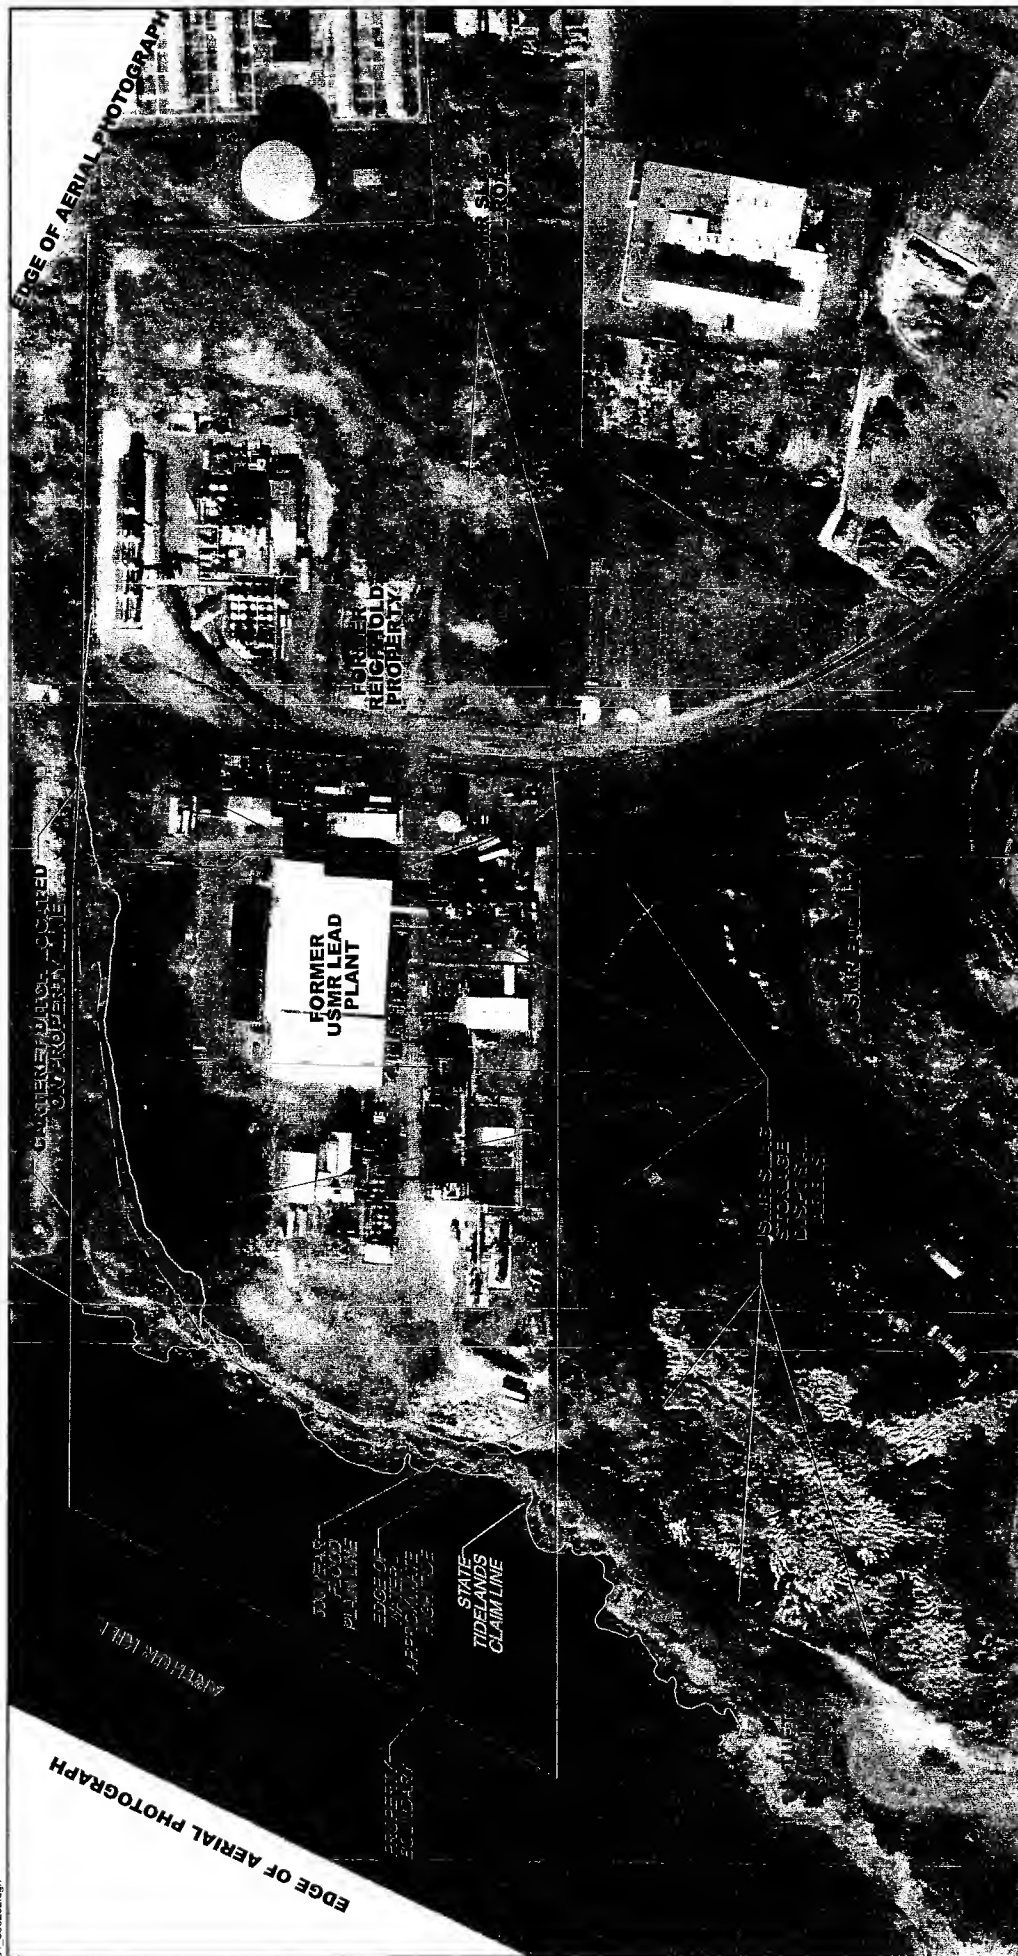
**Figure 2-3  
Former Reichhold Carteret Property  
1963 Aerial Photograph**

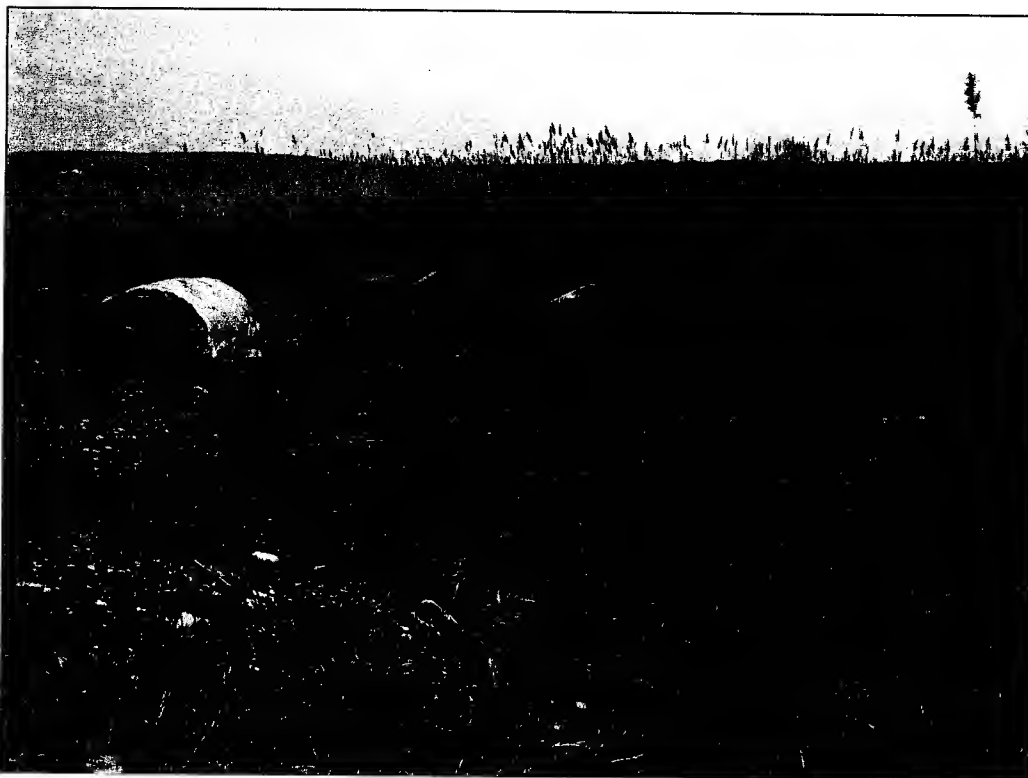
**LOCATION 1-PHOTO 1:** U.S. METALS REFINING (USMR) COMPANY MONITORING WELL (MW) AT EDGE OF TUFTS POINT MARSH (04/23/2008).

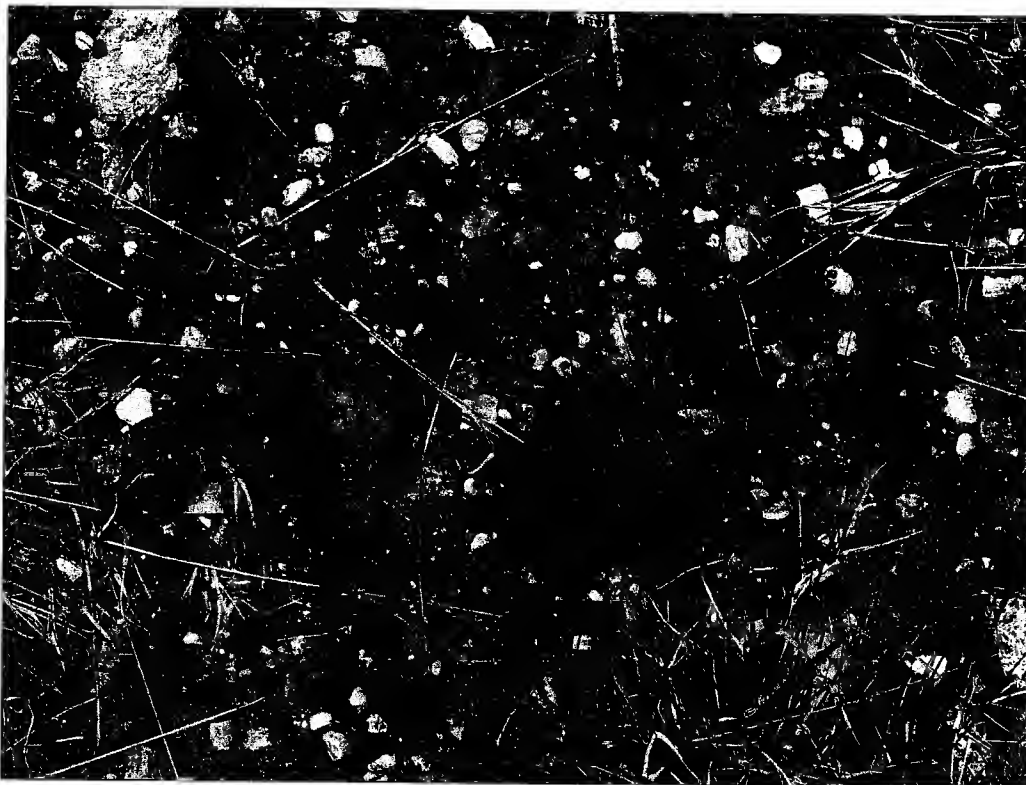
**LOCATION 1 PHOTO 2:** USMR PROPERTY NEAR MW, TUFTS POINT MARSH, AND ARTHUR KILL WITH SLAG COVERED SOILS IN FOREGROUND (04/23/2008).

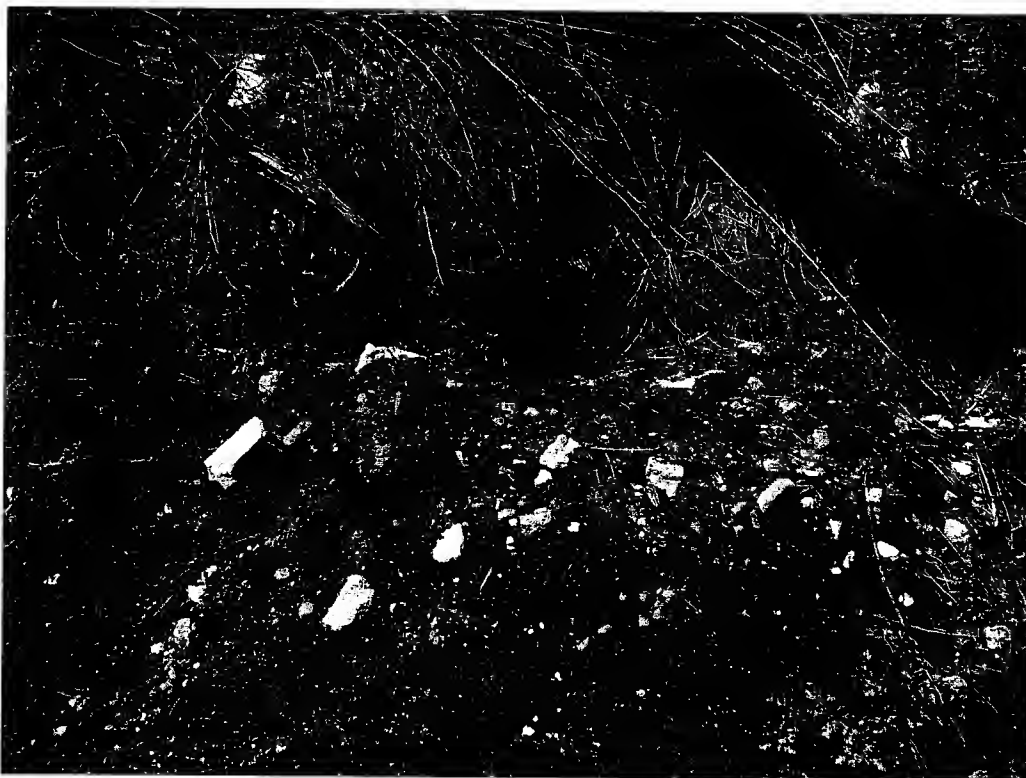
**LOCATION 2-PHOTO 1:** ANIMAL BURROW AT BASE OF FILL COVERED SLOPE NEAR FORMER REICHHOLD/USMR PROPERTY LINE (04/23/2008).

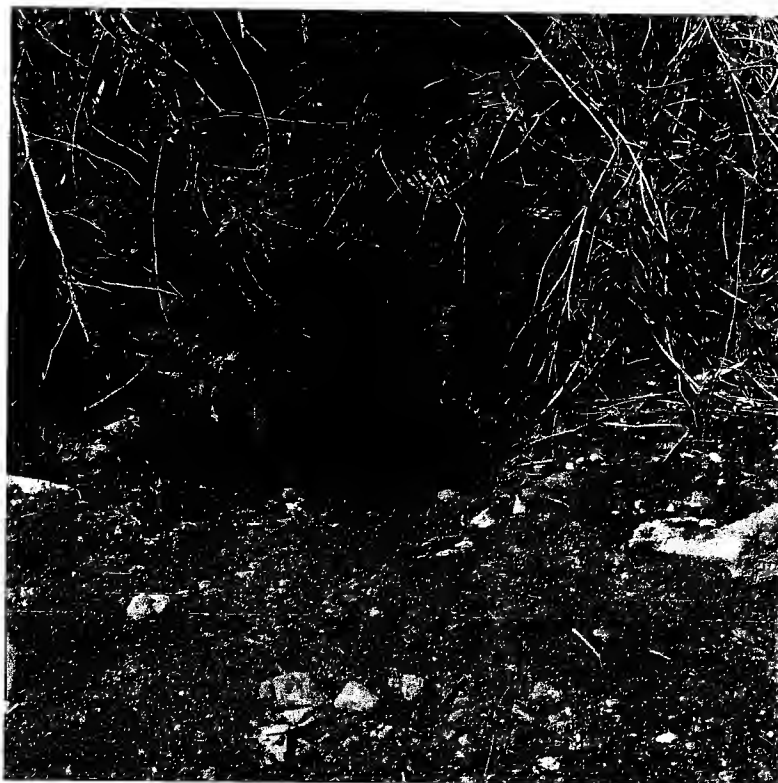
**LOCATION 2-PHOTO 2:** ANIMAL BURROW AT BASE OF FORMER USMR SLAG STORAGE/DISPOSAL AREA FILL SLOPE WITH EXCAVATED SLAG COVERED SOILS EVIDENT (04/23/2008).

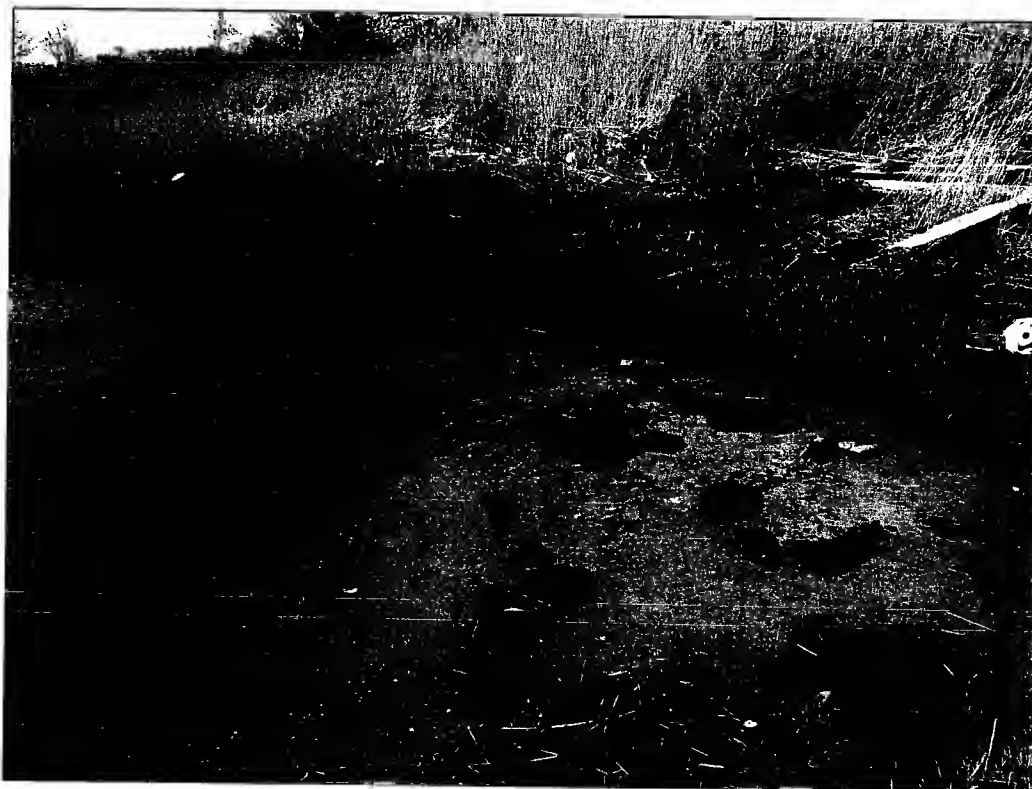
**LOCATION 3-PHOTO 2 :** SLAG AND SHELL COVERED SEDIMENTS AT SHORELINE OF  
ARTHUR KILL. SAMPLE COLLECTED (04/23/2008).

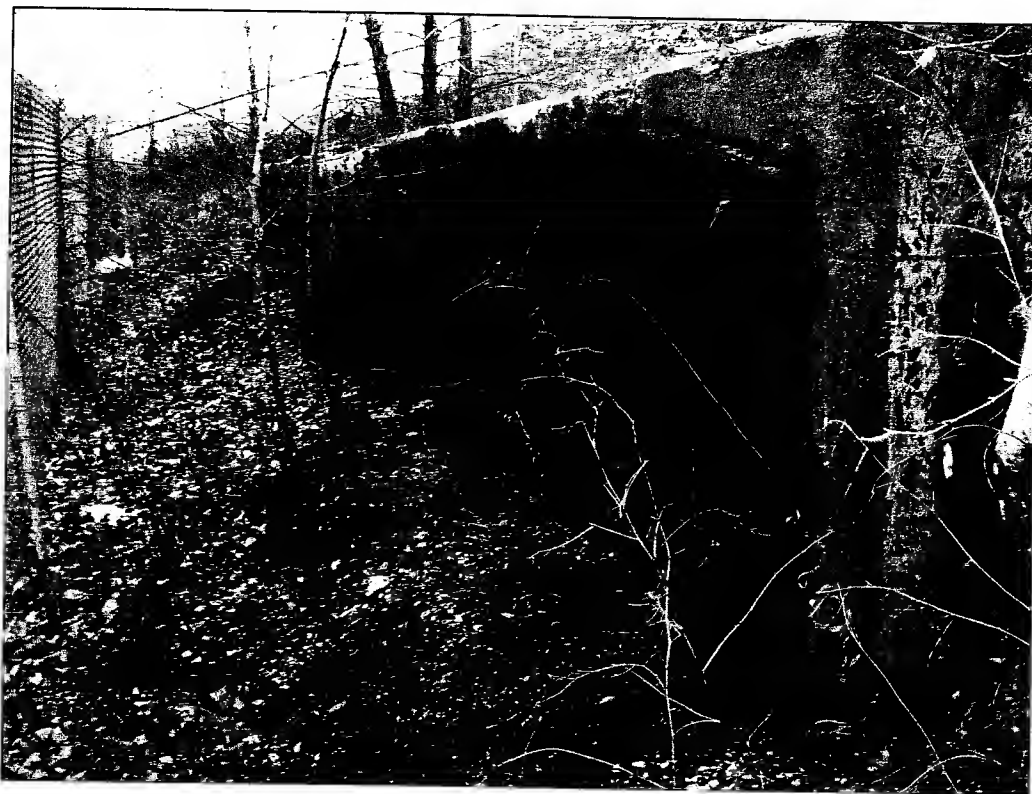
**LOCATION 5-PHOTO 1:** SLAG MATERIAL ON SURFACE AT EDGE OF FORMER REICHOLD AND USMR PROPERTY AND FENCE LINE NEAR CONCRETE BLOCKS (WINTER 2008).

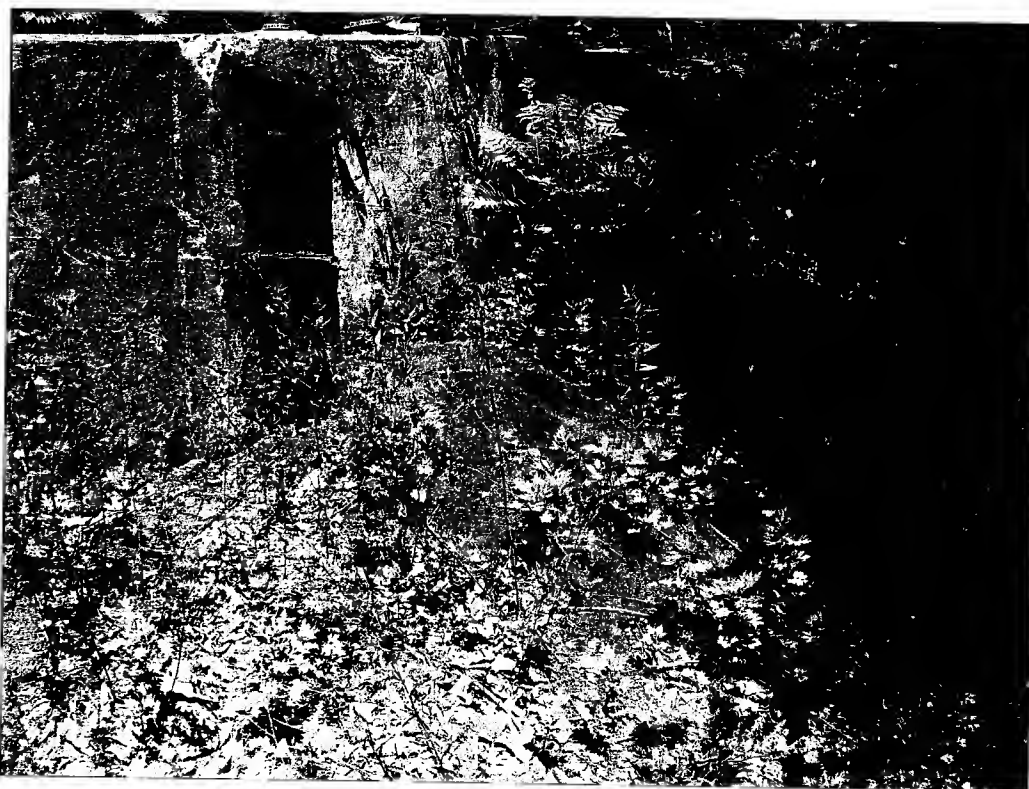
**LOCATION 5-PHOTO 2:** SLAG MATERIAL ON SURFACE AT EDGE OF FORMER REICHOLD AND USMR PROPERTY AND FENCE LINE NEAR CONCRETE BLOCKS (06/25/2008).

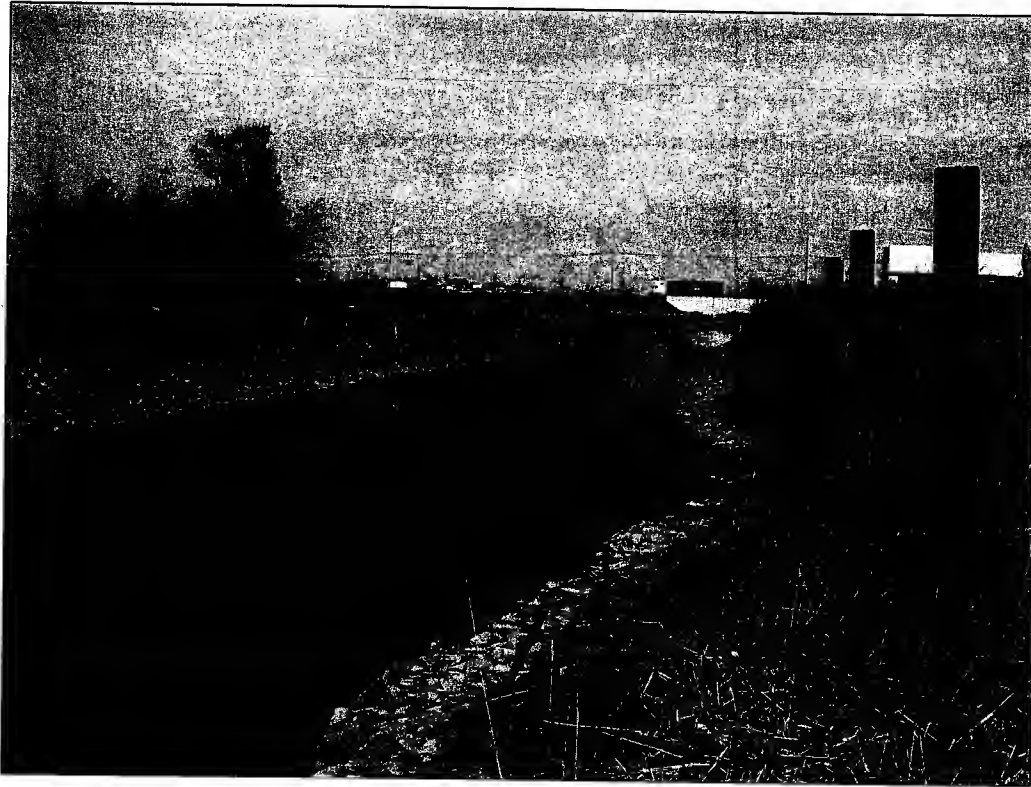
**LOCATION 7-PHOTO 1:** CARTERET DITCH RECENTLY REMEDIATED WITH GEOTEXTILE AND RIPRAP CAP NEAR THE CONFLUENCE WITH THE ARTHUR KILL LOOKING NORTH. LOCATION IS DOWN SLOPE OF USMR SLAG DISPOSAL AREAS ON THE FORMER REICHOLD PROPERTY (04/23/2008).

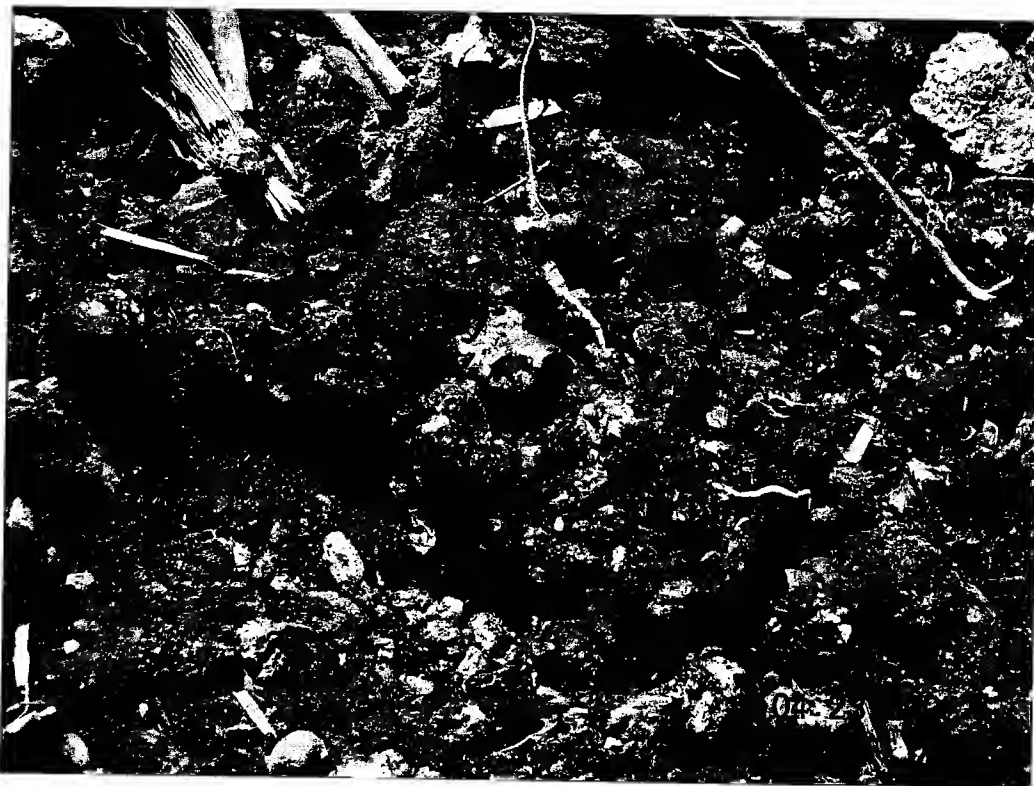
**LOCATION 8-PHOTO 4:** EAST SIDE OF CARTERET DITCH SOUTH OF MIDDLESEX AVENUE BRIDGE, EAST OF THE REMEDIATION CAP SILT FENCE. CLOSE-UP OF SLAG COVERED SOILS AT LOCATION DOWN SLOPE OF THE FORMER USMR LEAD PLANT AND SLAG DISPOSAL AREAS OF FORMER REICHHOLD PROPERTY (04/23/2008).

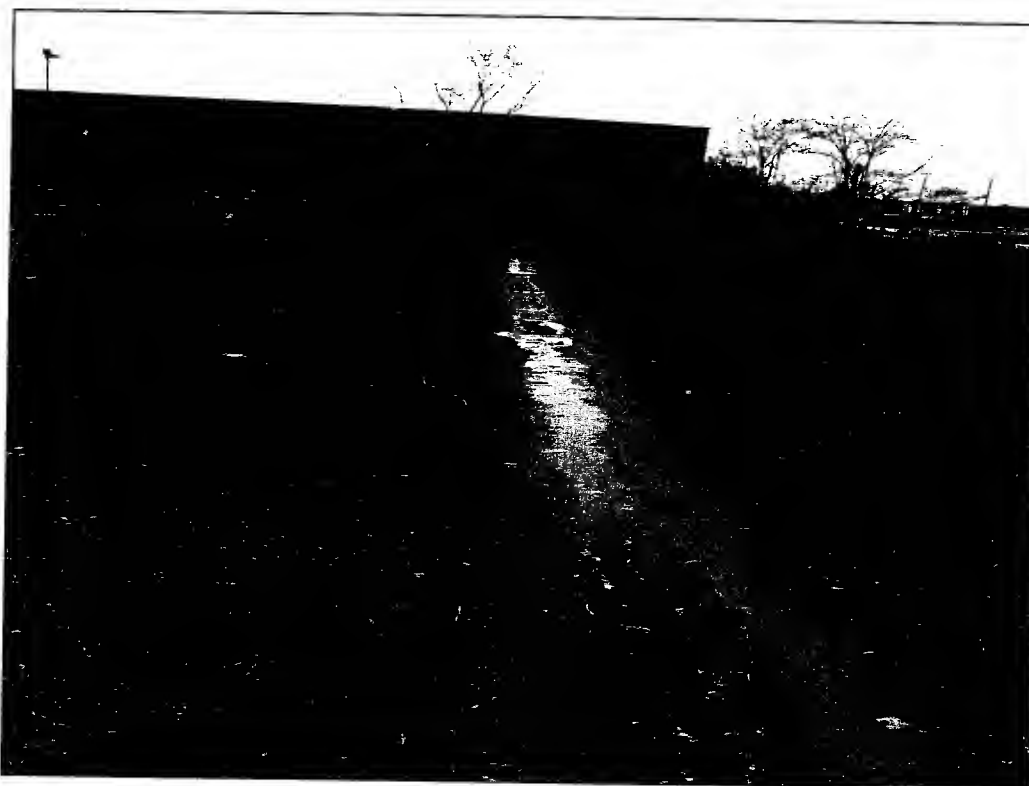
**LOCATION 10-PHOTO 8:** DRAINAGE SWALE THROUGH CARTERET WATERFRONT PARK LOCATED BETWEEN PARKING LOT AND PLAYGROUND FLOWING TO THE ARTHUR KILL. NOTE RED METALS STAINING OF WATER AND SWALE (04/23/2008).

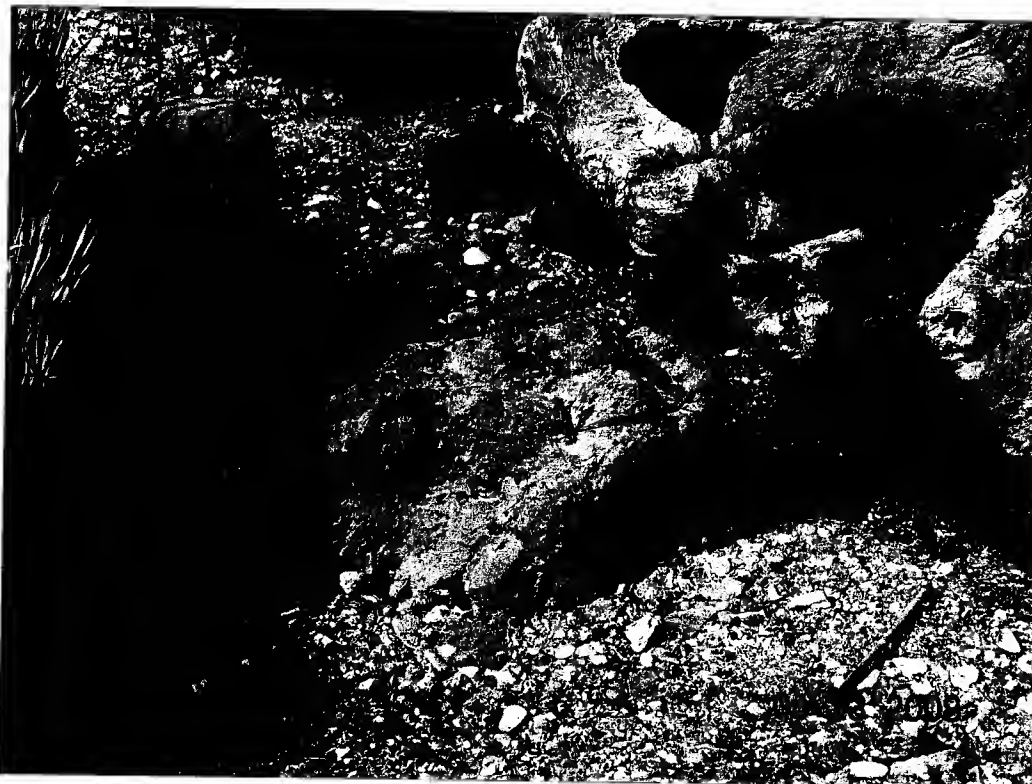
**LOCATION 11-PHOTO 2:** VETERANS MEMORIAL PIER & CARTERET WATERFRONT PARK LOCATED LESS THAN 1,000 FEET NORTHEAST OF FORMER USMR FACILITY. NOTE LARGE PIECE OF SLAG ON SHORELINE OF ARTHUR KILL TIDAL FLAT (04/23/2008).

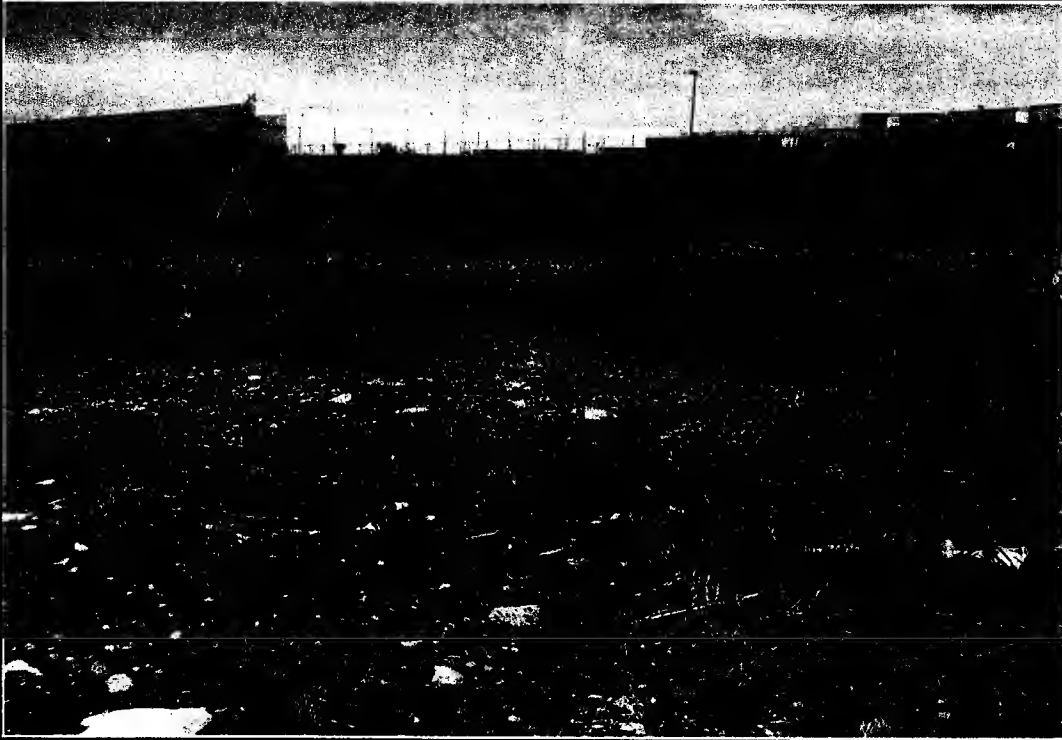
Description: Looking South-Southwest towards back of White Rose Distribution showing coarse, black slag at ground surface.			
Photo No. 4	Date: 05/15/07

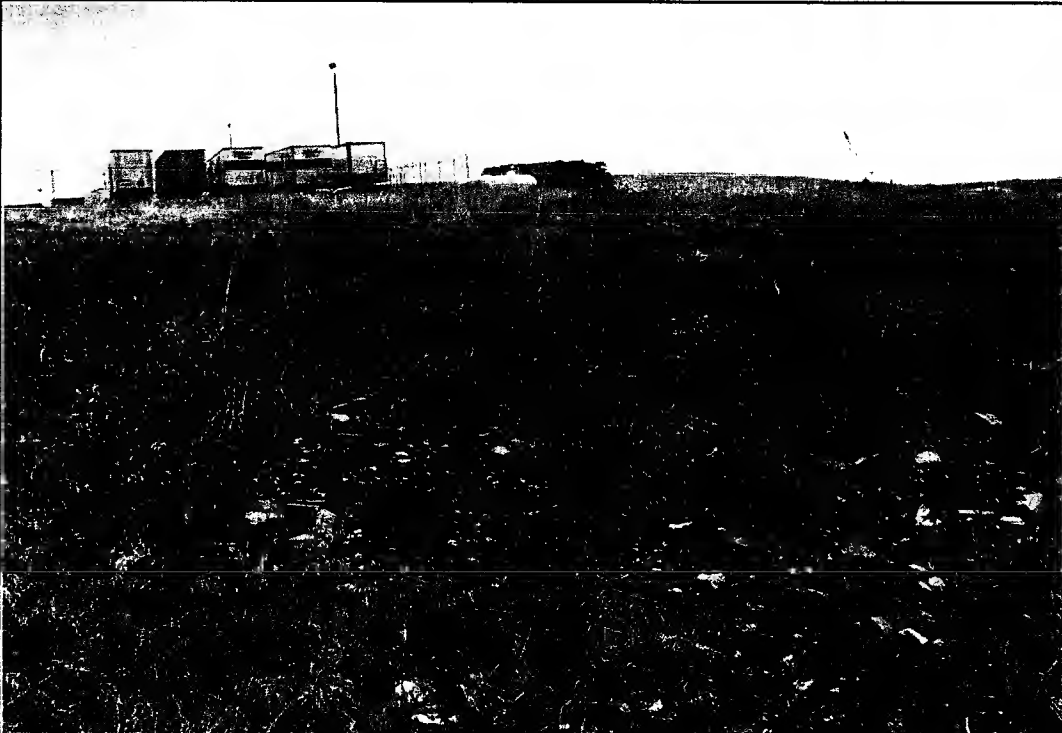
Description: Looking West towards back of White Rose Distribution showing coarse, black slag and amorphous slag material at ground surface.

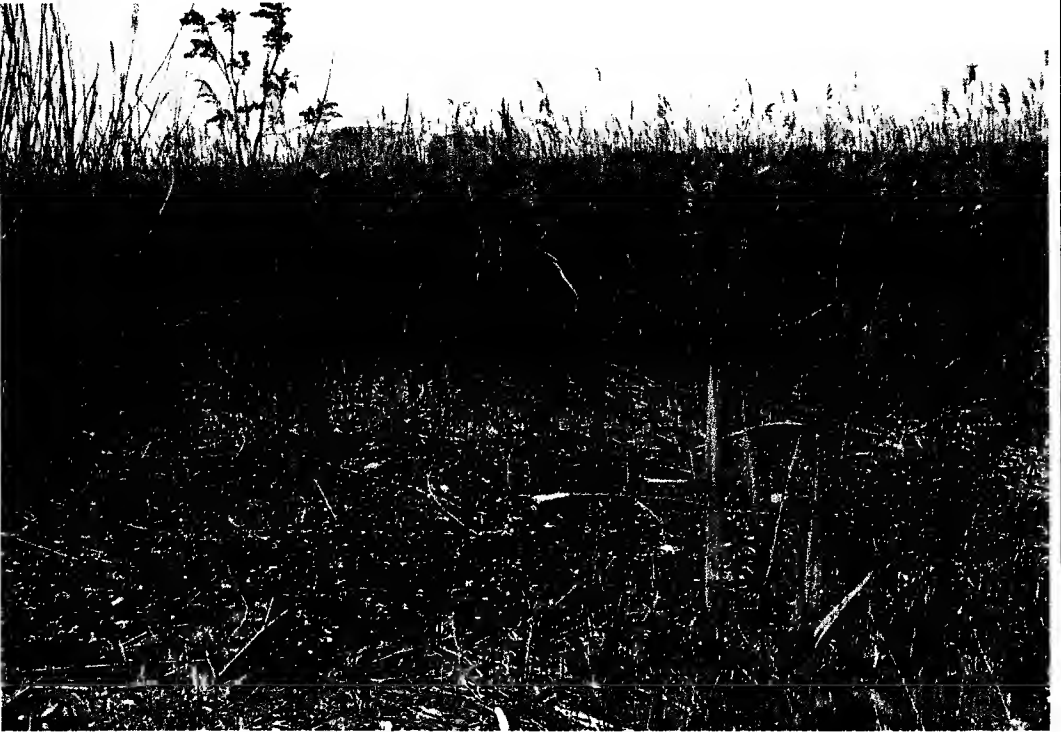
Description: Looking North towards Staten Island showing coarse, black slag and amorphous slag material in wetlands at ground surface.
